DERBYSHIRE COUNTY COUNCIL

MEMBER DECISION – HIGHWAYS ASSETS AND TRANSPORT

Petition Requesting the Review of Speed Limits on the A623 Stoney Middleton and Calver

Speed Reduction Proposal

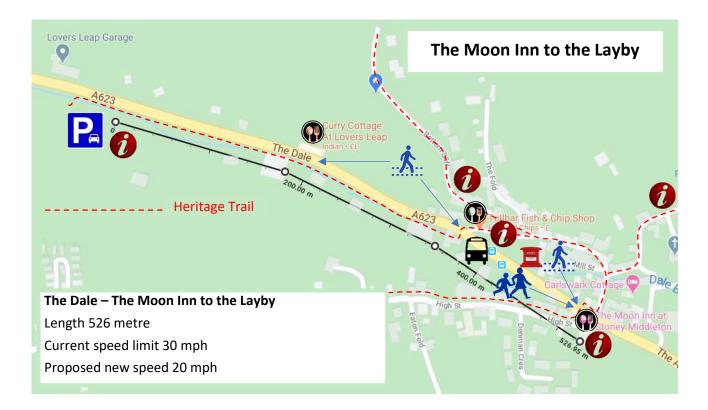
- > Right-hand roadside vehicular access and egress to 2 properties; and opposite to the left
- A blind turning to an access lane to properties on Denman Crescent; followed immediately by
- The crossroads with High Street and The Nook.

This is a particularly dangerous junction with an oblique left hand turning to High Street and a blind entrance to The Moon Inn car park and to the right a blind, narrow, dog-leg turning onto The Nook. Over the last two years, there have been three vehicular collisions with bollards outside the hairdresser's caused by a combination of the narrowness of the road, inappropriate parking and excessive driving speeds. Please note, the photograph below was taken before the last remaining bollard was demolished

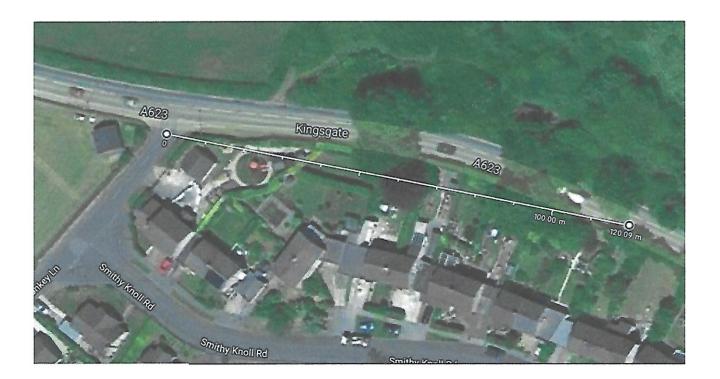
Required Visibility

Furthermore, the visibility splay of some of the access roads in the village (normally 4.5m x 120m) are seriously deficient and present a hazard to vehicles turning onto the A623.

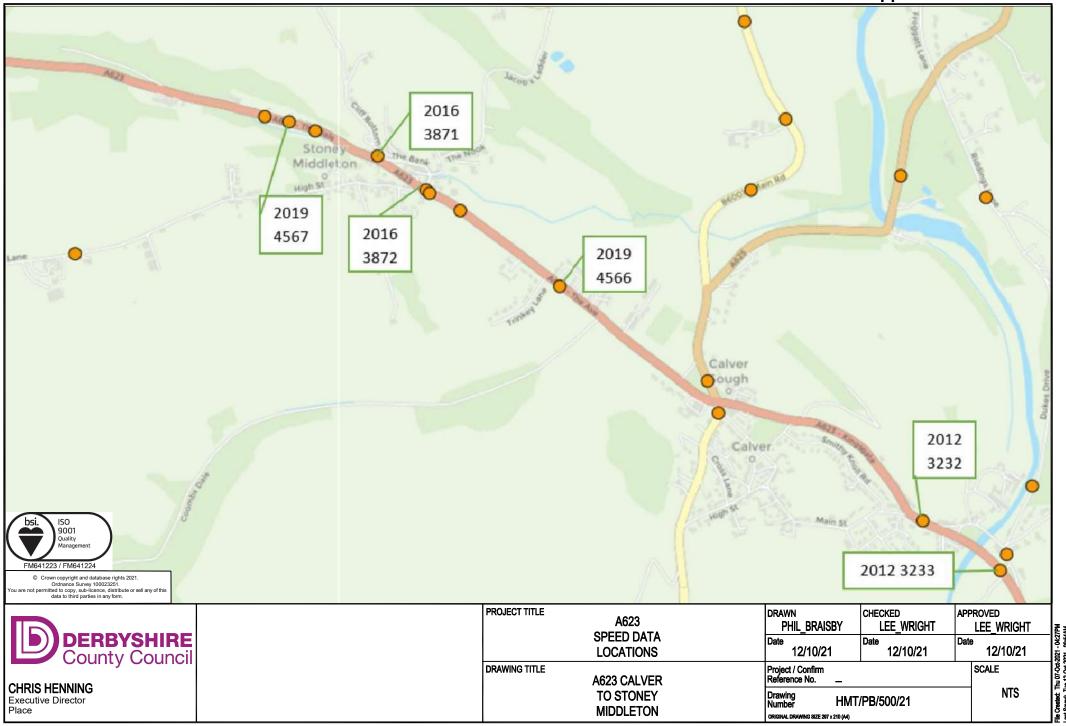
Appendix 4

(for locations of the Speed Survey See Appendix 4)
