# A632 Walton to Matlock

# Collision Summary 01/03/2017-29/02/2020

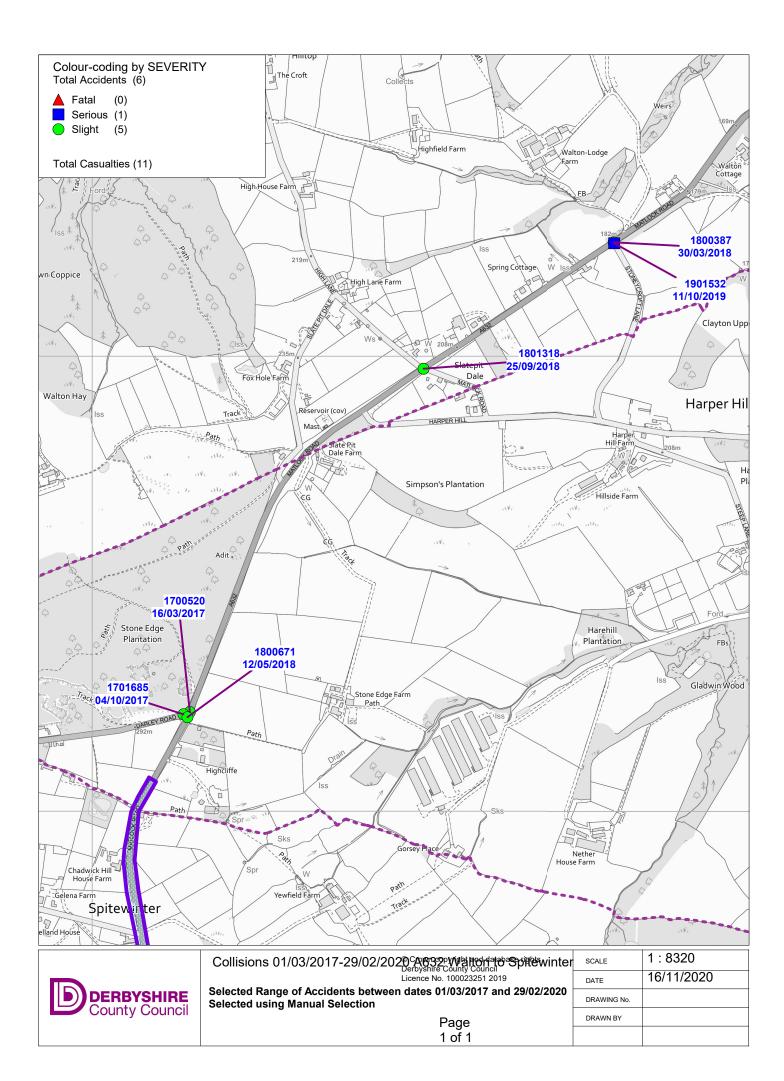
### From 40 mph limit in Walton to 40 mph limit in Spitewinter

5 collisions in the last 3 years (1 Serious, 4 Slight).1 in 2017, 3 in 2018 and the most recent in October 2019 (could be more but only have data to Feb 2020). Only 2 on a wet road surface and 2 in hours of darkness.

2 collisions likely to be speed related (40%). (Also, could a lower speed limit aid cars turning on or off A632 when failing to see or judge speed of other vehicles)?

2 collisions at J/W Stoneycroft Road

1800387 – March 2018 – Slight. Southbound Hit and Run driver veers into Northbound other vehicle. 10pm Friday night. Wet. Dark.

1901532 – October 2019 – Serious. Rear shunt at speed by northbound young car driver into car about to turn right into Stoneycroft Road. Wet. Day.

1801318 – September 2018 – Slight. Car pulls out of junction SE to NW to cross A632 into High Lane, fails to see southbound car. Dry. Day. (if speed lower, more chance of seeing southbound car)?

2 collisions at J/W Darley Road B5057

1800671 – May 2018 – Slight. Car turns right off A632, fails to see northbound motorcyclist. (if speed lower, more chance of seeing motorcyclist)? Dry. Dark.

1700520 – March 2017 – Slight. Southbound rear shunt in slow moving traffic. Dry. Day.

(3<sup>rd</sup> collision showing here on map is a rear shunt on the B road).

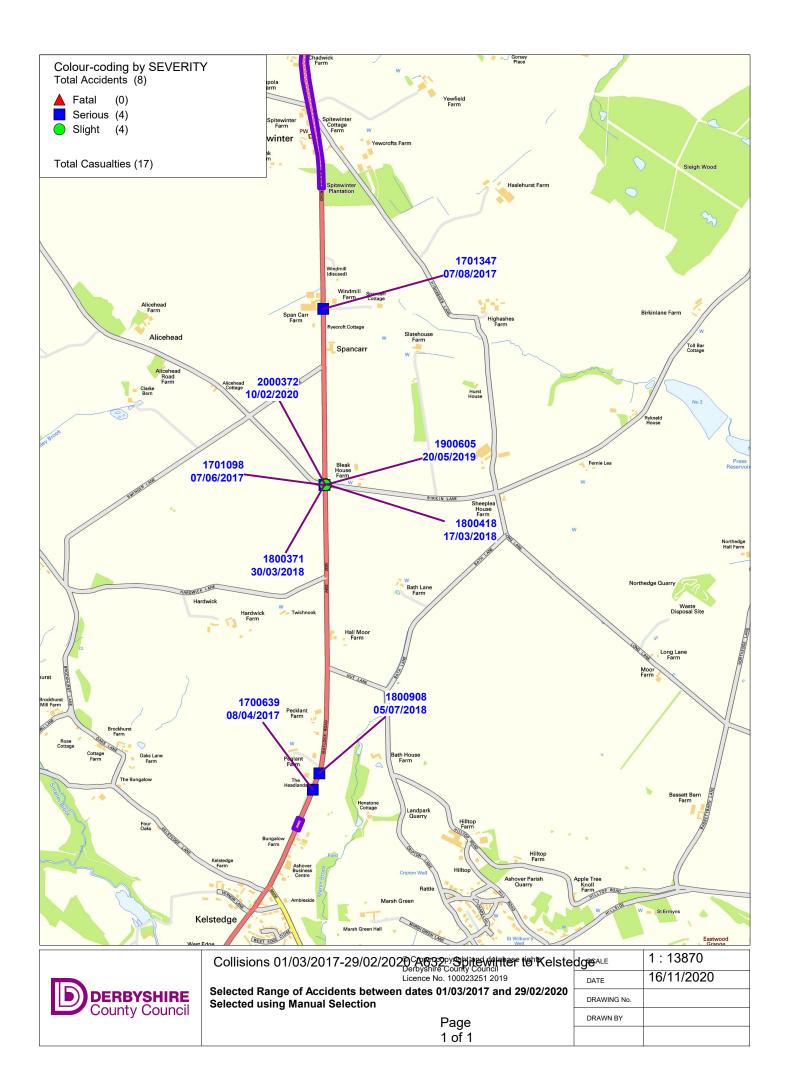
# From 40mph speed limit in Spitewinter to 40mph speed limit North of Kelstedge

8 collisions in the last 3 years (4 Serious, 4 Slight). 3 in 2017, 3 in 2018, 1 in 2019 and 1 in 2020. 5 on a dry road surface, 1 on wet and 2 in snow. 3 collisions in hours of darkness.

1701347 – August 2017 – Serious. Near Rye croft Cottage. Southbound young motorcyclist undertakes another southbound young motorcyclist. They collide and one hits a telegraph pole. Dark. Dry.

5 collisions at J/W Birkin Lane and Alicehead Road.

In the last 3 years, of the 5 collisions at this junction, the most common pattern was 3 collisions with eastbound vehicles on Alicehead Road. One involved a motorcycle colliding with a northbound car and in 2 collisions, vehicles in snow, failed to stop at the junction. Other collisions were a westbound vehicle going across from Birkin Lane and one was a right turn into Birkin Lane. All collisions were in daylight.

2 collisions between Birkin Lane crossroads and 40mph limit North of Kelstedge.

1800908 - May 2018 – Serious. Near The Headlands. Single Vehicle Loss of Control southbound on bend, at speed. Car hits wall. Dry. Dark.

1700639 – April 2017 – Serious. Approx 30m south of The Headland. Single Vehicle, Young Car Driver, Loss of Control southbound on bend. Car hits wall. Driver impaired by alcohol. Dry. Dark. (possibly speed related).

(could a lower speed limit possibly have influenced the outcome of half the collisions on this section)?

In June 2014 an interactive sign was installed, and surfacing was carried out, but within a year of these measures there were 2 serious collisions. This junction has come up in the last 4 annual cluster runs. Paving over vegetation was considered but it was felt that could create drainage issues, so it was not carried out, although some vegetation was cut back.

A common pattern is vehicles pulling out A632 from Birkin Lane, some turning right some going straight across, all in daylight, with good visibility but drivers still pull out into traffic.

When the 2020/2021 scheme was added to the programme there were 7 collisions in 5 years here: 3 pull outs from Birkin Lane, 1 right turn into Birkin Lane, 1 motorcyclist overtaking whilst a car turns right into Birkin Lane. 2 collisions involved eastbound vehicles on Alicehead Road 1 of these a motorcyclist and the other a car in snow failed to stop. Data available over 9 months since the scheme was added to the programme shows one collision when an eastbound van on Alicehead Road failed to stop at the junction in snow and collided with a southbound car on A632. (please refer to labelled map).

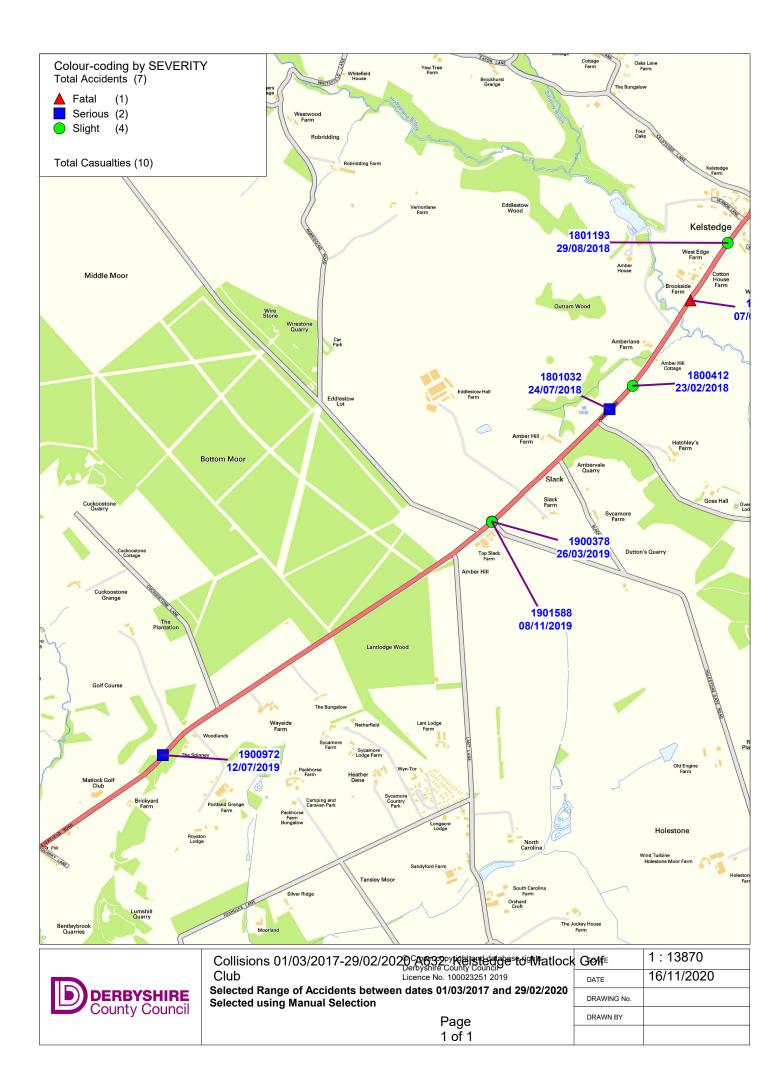
### From 40 mph limit South of Kelstedge to 40 mph limit near Matlock Golf Club

Approx 3100m length. 7 collisions in the last 3 years. (1 fatal, 2 serious, 4 slight). 4 in 2018, 3 in 2019. Only 1 on a wet road, but 4 during hours of darkness (57%), higher than average.

1801193 – Aug 2018 – Slight. Approx. 100m South of J/W Vernon Lane. Northbound rear shunt. Dark. Dry. Driver Impaired by Alcohol.

1800749 – June 2018 – Fatal. South of Brookside farm. Southbound older pedal cyclist Loss of Control. Dry. Day.

1800412 – Feb 2018 – Slight. South of Amber Lane Farm. Southbound car pulls out to overtake traffic going up steep hill into path of southbound car, already overtaking other traffic. Dry. Dark.

1801032 – July 2018 – Serious. Approx. 260m south of Amber Lane Farm. Southbound older car driver attempts U turn, hits southbound vehicle. Dry. Day.

2 collisions at J/W Holestone Gate Road.

1900378 March 2019 – Slight. Southbound car overtakes car slowing to turn left into Holestone Gate Road and collides with car turning right out of Hole Stonegate Road. Dry. Day. (overtaking driver considered at fault).

1901588 – November 2019 – Slight. Older car driver fails to look/judge when turning right out of Holestone Gate Road. Southbound car attempts to avoid it but hits 2 other vehicles. Wet. Dark.

1900972 -July 2019 – Serious. Approx 100m south of The Spinney. Northbound single vehicle loss of control, collides with tree. Dry. Dark.
